Number C.1
Section Carburetters and
Fuel System

PETROL FUMES

(2.4, 3.4 and 3.8 litre Mark 2 models)

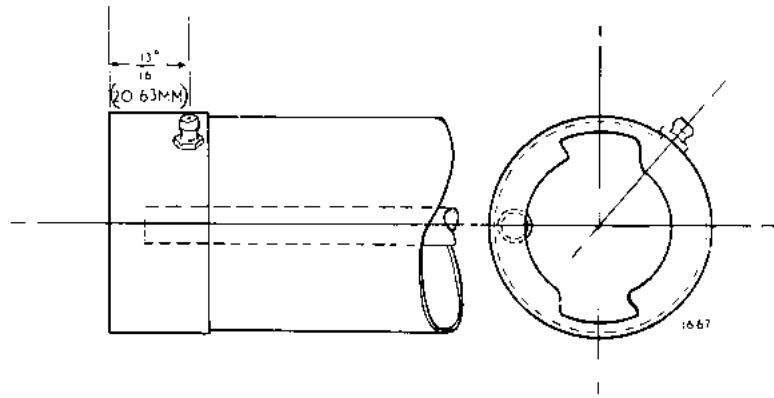
FIG 1

If, however, the fumes are only noticeable when the tank is less than half full and when one or more windows are open, the complaint most probably arises due to fumes from the petrol cap vent being sucked into the car, in which case proceed as follows:-

Using a No.3 .213" (7.69 mm) drill; drill a hole $13/16$ " (20.64 mm) from the top edge of the filler pipe as shown in Fig.1. Tap the hole $\frac{1}{2}$ " UNF. Coat the drill and tap with grease as a precautionary measure against pieces of metal falling inside the filler pipe.

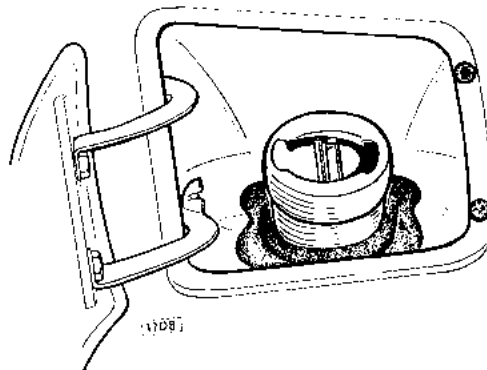
A modification to overcome petrol fumes has now been incorporated in production and consists of a breather pipe in the filler neck (adjacent to the vent pipe) and a non-vented filler cap. Cars so modified can be easily identified by removing the filler cap and noting if there are two pipes in the filler neck as shown in the illustration below; previous type petrol tanks have a single vent pipe in the filler neck.

The service modification for overcoming petrol fumes as described in Service Bulletin C.1 should obviously not be carried out on cars which incorporate the above modification and if petrol fumes are present the cause should be sought elsewhere.

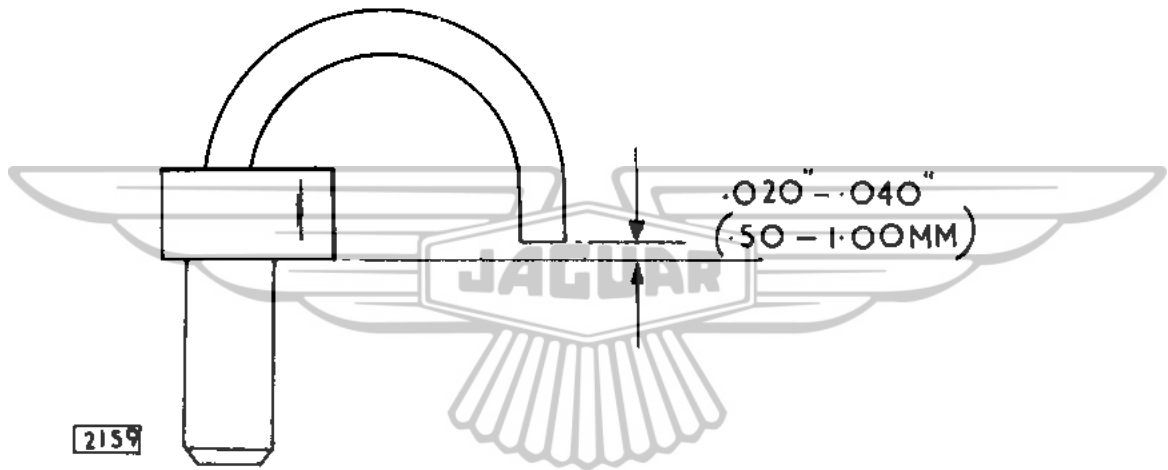
In cases of heavy fuel consumption on 2.4 litre cars, the usual checks on choke levers, throttle synchronisation, timing, tuning, etc., should be carried out but in addition the accelerator pump discharge injector tube should be checked for correct positioning.

The position should be checked by placing a straight edge across the lower face of the mounting block and measuring the gap between the end of the tube and the straight edge as shown in the illustration overleaf. The correct gap should be .020" - .040" (.50 - 1.00 mm). If this dimension is not correct, remove the assembly and fit a replacement (Part Number 5032) taking care to refit the gasket under the base of the assembly and tighten the locating screw. The injector tube must not be bent as there is a danger of loosening the tube in the mounting block.

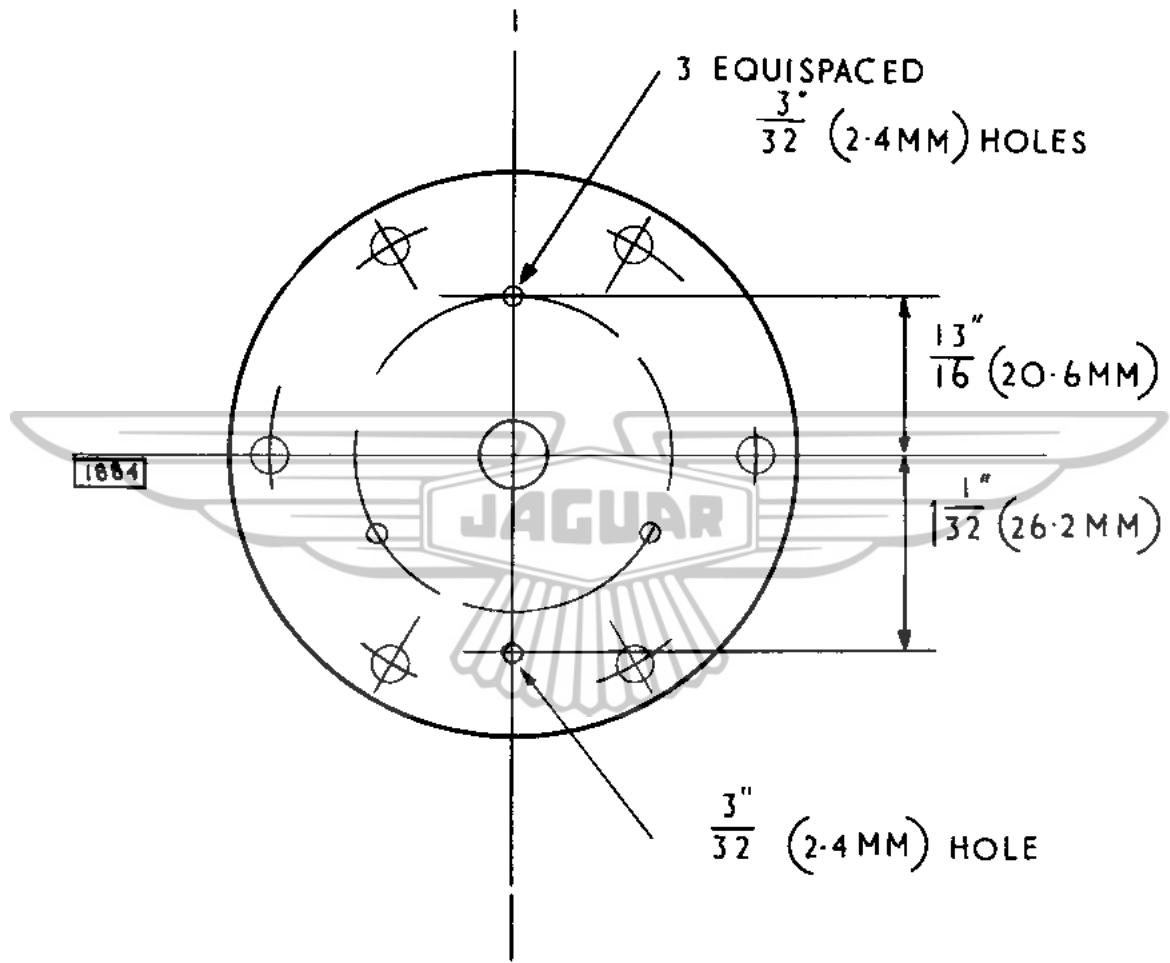
If failure of the fuel pump is experienced early in its life it may be due to initial settling resulting in variation of the diaphragm setting, thus restricting the "throw-over" of the toggle mechanism.

Whilst the pump is dismantled it is also advisable, particularly in hot climates, to pierce the upper diaphragm only (that is, the one next to the rollers) as shown in the sketch overleaf.

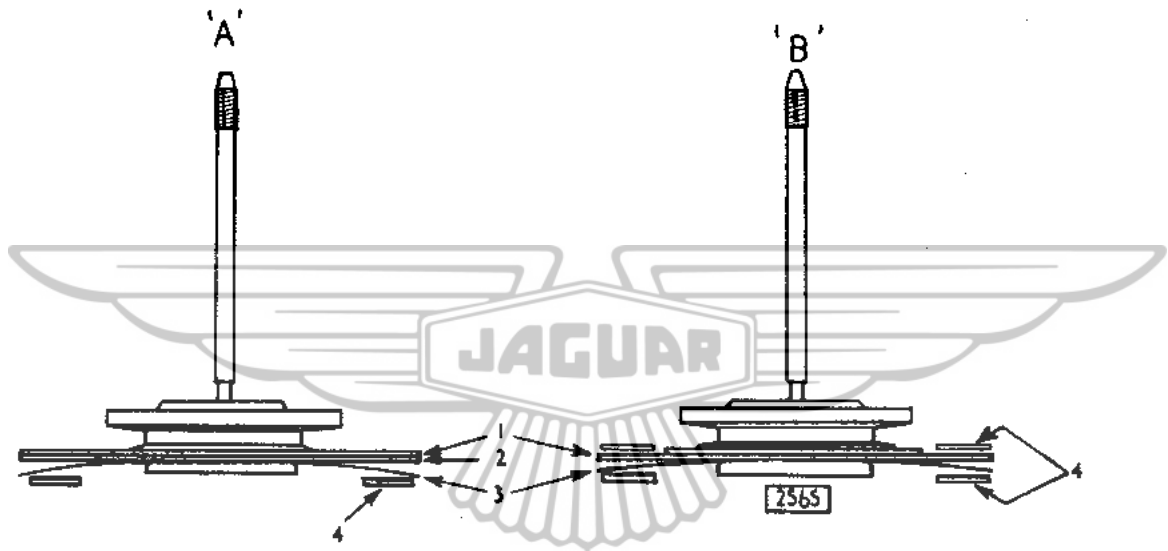
Cars with the AUB 152 type fuel pump (see Service Bulletin C.10) now have a modified type diaphragm (Part No. 9098 unchanged) "B" on the illustration overleaf. This diaphragm has a single neoprene leaf (Item 1) and a translucent plastic leaf (Item 3) and must be fitted with a gasket (Item 4) at each side of the diaphragm. Two gaskets will be supplied with each diaphragm.

The earlier diaphragm ("A" on illustration) has two neoprene leaves (Item 1 and 2) and a translucent plastic leaf (Item 3). This type of diaphragm had only a single gasket (Item 4) fitted.

If on cars prior to the introduction of the new diaphragm trouble is experienced with the pump failing to operate at temperatures below -7°C (22°F) either the latest type pump or the new single leaf diaphragm should be fitted.

If a new diaphragm is fitted it must be adjusted in accordance with the instructions given on pages C.22 and C.23 of the Mark 2 Service Manual except that the diaphragm must be backed off (unscrewed) 7 holes and not 5-6 as stated in the manual.

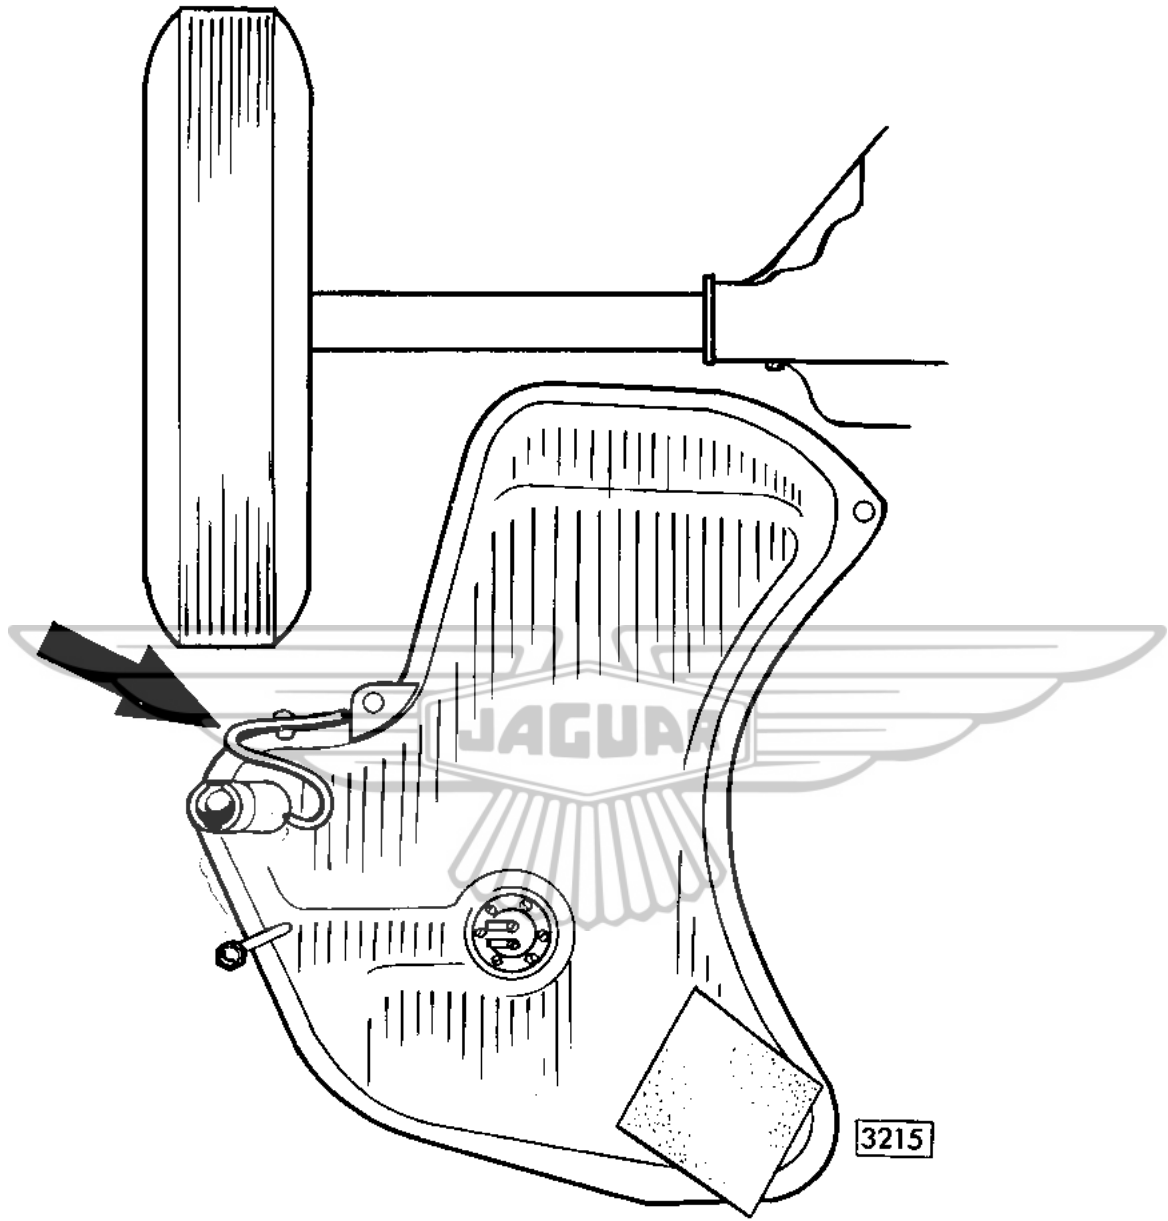
Cases have been experienced of petrol starvation due to the petrol tank breather becoming blocked with road dirt and also water entering the tank through the breather pipe.

In this event the breather pipe should be cleaned and if positioned to rear of the filler neck the pipe should be re-routed to the front and clipped to the petrol tank flange as shown in the illustration.
