DATE: OCTOBER 1992

REF: JD 16/92

## ERRATA

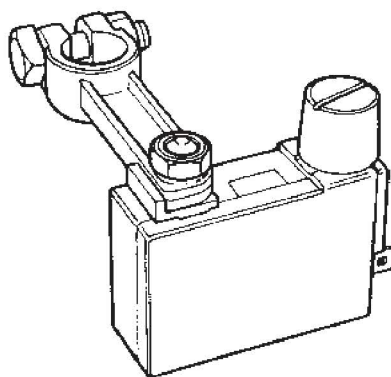
FIG 1

Owing to the relocation of the battery into the boot at 93 MY, a revised battery transit relay has been introduced, (see Fig 1).

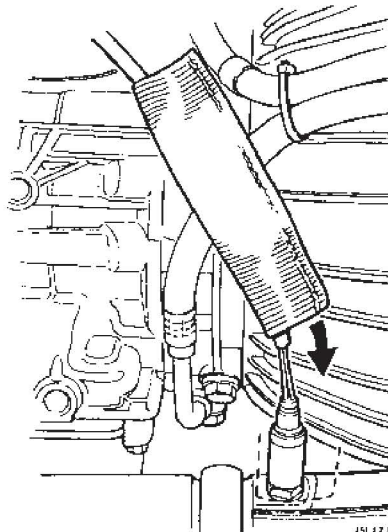
SLEEVE  
C. 33139/4

Following reports of the intermittent display of "Fuel Failure 44" on the instrument pack, it was found that this symptom could be caused by water penetrating the lambda sensor.

A lambda sensor splash-shield has been introduced from VIN 664941, which can be fitted retrospectively and should be installed whenever a lambda sensor is changed. This will reduce the possibility of water ingress.
